Manhole Inspection Summary

Manhole # S21EE2008MH

Insp Date: **11/16/06 8:20 AM**

Location Address: **1206 TERRACE GLEN**

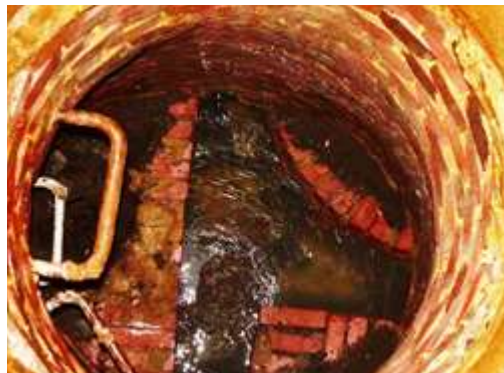
Top View

Evidence of surcharge - Bench debris.
Channel debris. Corroded steps.

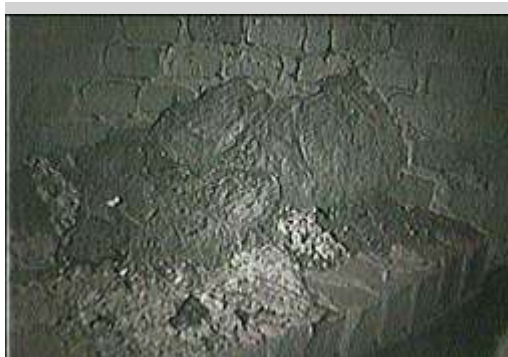
Defect

Bench debris.

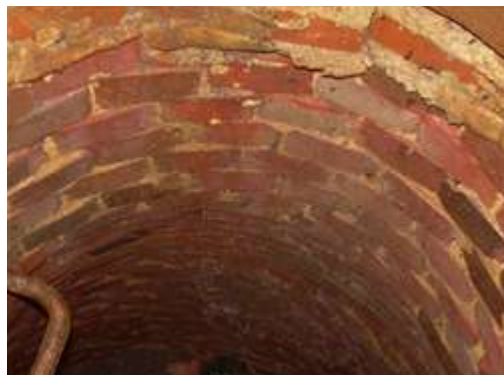
Defect

Adjustment deterioration and infiltration.
Corbel infiltration.

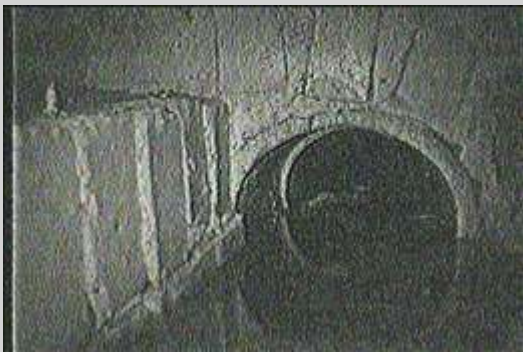
8 in. Circular Gravity Sewer Pipe Out @ 12 O'Clock

Channel deterioration.

Deposits: ☐ None ☒ **Mud** ☐ Sludge ☒ **Debris** ☐ Grease

Silt Depth: **2** (in.) Deposits Extent: **Medium**

Infiltration: **Evidence** Pipe Seal Cond: **Cracked**

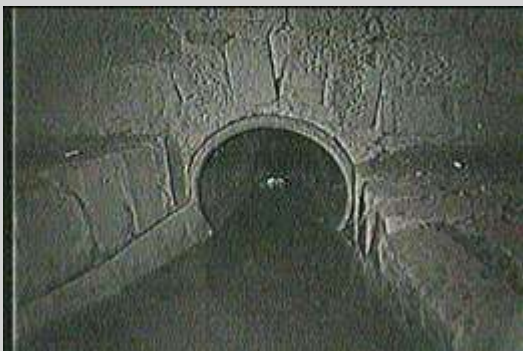
8 in. Circular Gravity Sewer Pipe In @ 3 O'Clock

Deposits: ☐ None ☒ **Mud** ☐ Sludge ☒ **Debris** ☐ Grease

Silt Depth: **1** (in.) Deposits Extent: **Light**

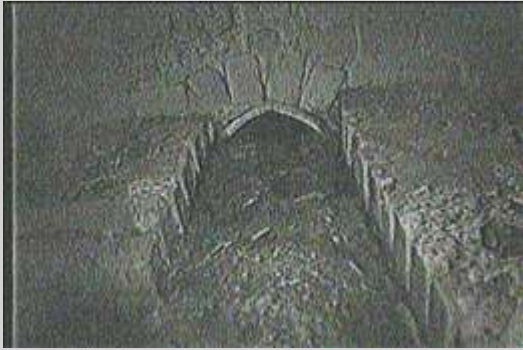
Pipe In @ 6 O'Clock

Deposits: ☐ None ☒ **Mud** ☐ Sludge ☒ **Debris** ☐ Grease

Silt Depth: **5** (in.)

Deposits Extent: **Heavy**
